Tree Health Monitoring of Risky Trees in the Hotel Open Space: A Case Study in Rancamaya, Bogor

Irfan Martiansyah^{*1}, Rizmoon Nurul Zulkarnaen¹, Muhammad Rifqi Hariri¹, Prima Wahyu Kusuma Hutabarat¹, Fitri Fatma Wardani²

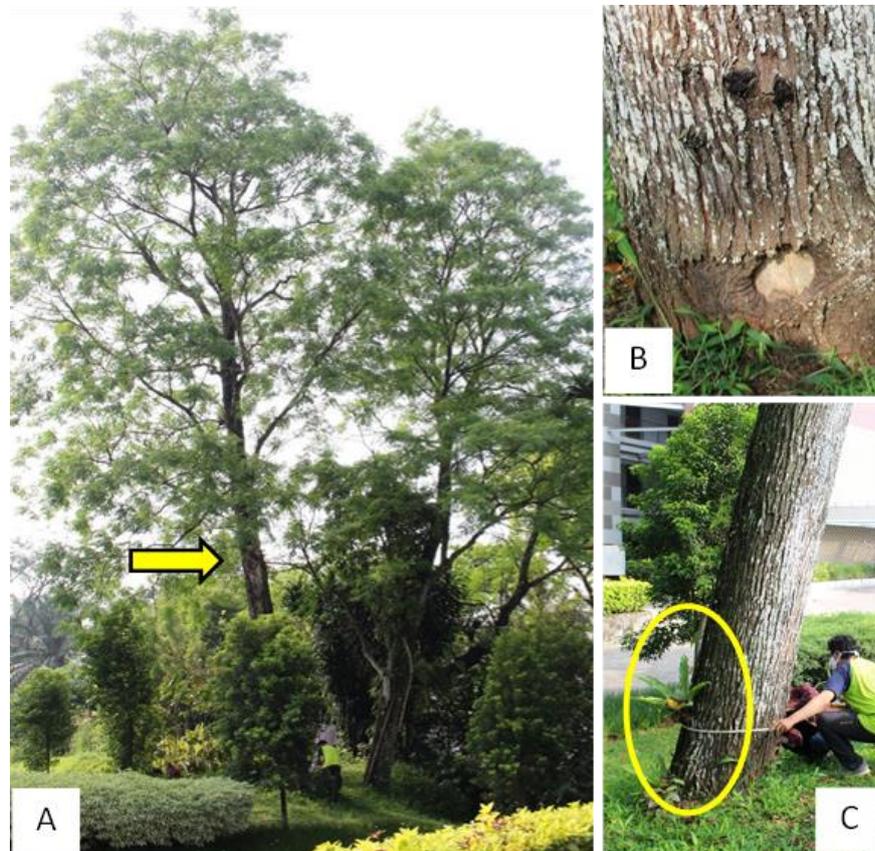
The visual observation results show that the condition of the trunk is slightly tilted towards the parking area (around 80°) but is still within reasonable limits. The tree crown and branching condition were still reasonably good, the crown density was average and balanced in all directions,

and there was no damage to the tree crown (**Fig. 4a; 4c**). At the base of the trunk, there is a scar/pruning process that is in the process of closing the wound, but there are no signs of further damage and rot in the scar (**Fig. 4b**). In the trunk, epiphytic plants from the ferns, *Asplenium* sp., which does not damage the host, but in the long term, can increase the moisture and substrate deposition around the roots can invite disease rot the bark (**Fig. 4c**).

Fig. 4. Tree 1 (*M. azedarach*). A. In whole natural appearance; B. Damage to the lower trunk has scars that are in the process of closing; C. The condition of the trunk with a slope of 80° and the presence of epiphytes in the trunk.

good and has a low risk of falling. Hence, the recommended mitigation efforts for tree 1 are as follows: (1) cleaning of epiphytic plants attached to the trunks, (2) installing warning signs such as “beware of broken branches” because the tree is close to the road and parking area, and (3) maintenance around the root neck, such as mulching treatment to ensure and prevent a dampened root neck.

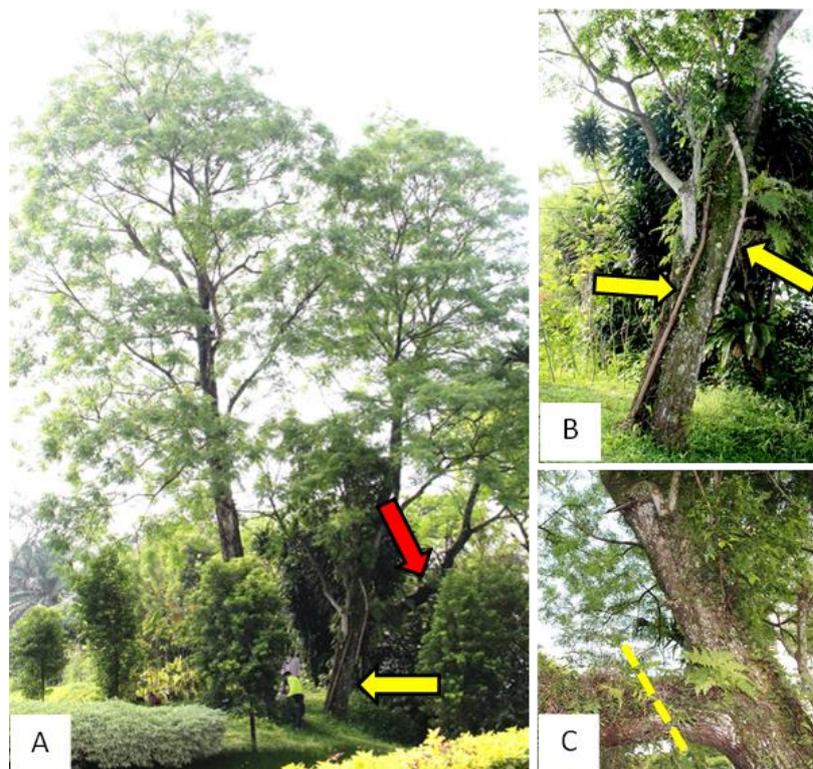
The visual observation results show that the trunk is tilted (about 70-75°) towards the parking and lower pedestrian areas (**Fig. 5a**). The topography of the tree-growing site is also a cliff with a 45° slope. The condition of the tree crown and branching is still reasonably good. The crown density is average, and there is no damage to the tree crown, but branches or large tree branches point towards the slope (**Fig. 5a; 5c**). This large branch is the main burden on the tree, which is thought to cause the tree's pitch. On the trunk and main branches, there are two strangler or strangler plants (*Ficus* sp.) (**Fig. 5b**) and several epiphytic plants of pigeon orchid (*Dendrobium crumenatum*), *Pyrrosia piloselloides*, and other types of ferns. Strangler plants that have stabilized and whose roots reach the ground will grow larger and choke the host plant to death slowly, and a strangler plant crown will replace the crown. Epiphytic plants, especially dragon scales ferns, accelerate weathering of the bark (**Fig. 5c**).

Fig. 5. Tree 2 (*M. azedarach*). A. In whole natural appearance, the trunk tilts to the south or cliff area (yellow arrow) with large branches towards the cliff (red arrow); B. Presence of two strangler plants C. Presence of epiphytic plants on the trunk and large branches, as well as the pruning area (yellow dashed line).

The PiCUS-3 Sonic Tomograph in tree 2 was carried out on three layers at the height of 30 cm (L1), 80 cm (L2), and 180 cm (L3). Good condition of the trunk at the height of 30 cm (L1), 80 cm (L2), 180 cm (L3) showed that the weathering process of 1%, 1%, and 0% (respectively) with wood solidity 96%, 93%, and 98% (sequentially). This condition is considered good and has a low risk of falling. Heavy pruning of large branches that leads to the cliff is recommended because it becomes a burden on the tree and causes the slope of the trunk. Pruning can be adjusted to the recommendations, or the branch can be cut and left about 1 m in height from the base. Cleaning epiphytic plants attached to the trunks, especially *P. piloselloides* and other ferns, is also vital to be conducted. Two strangler plants are relatively established and challenging to destroy. We recommend leaving them alone, considering that the roots of the strangler plants will strengthen the stand of the host tree. In the long run, the host tree will be replaced by the whole strangler plant. Installing warning signs to warn about broken branches' potential hazards is strongly recommended because the tree location is close to vehicle roads, pedestrians, and parking areas. In addition, mulching around the root neck can be done to ensure the condition of the root neck is not damp.

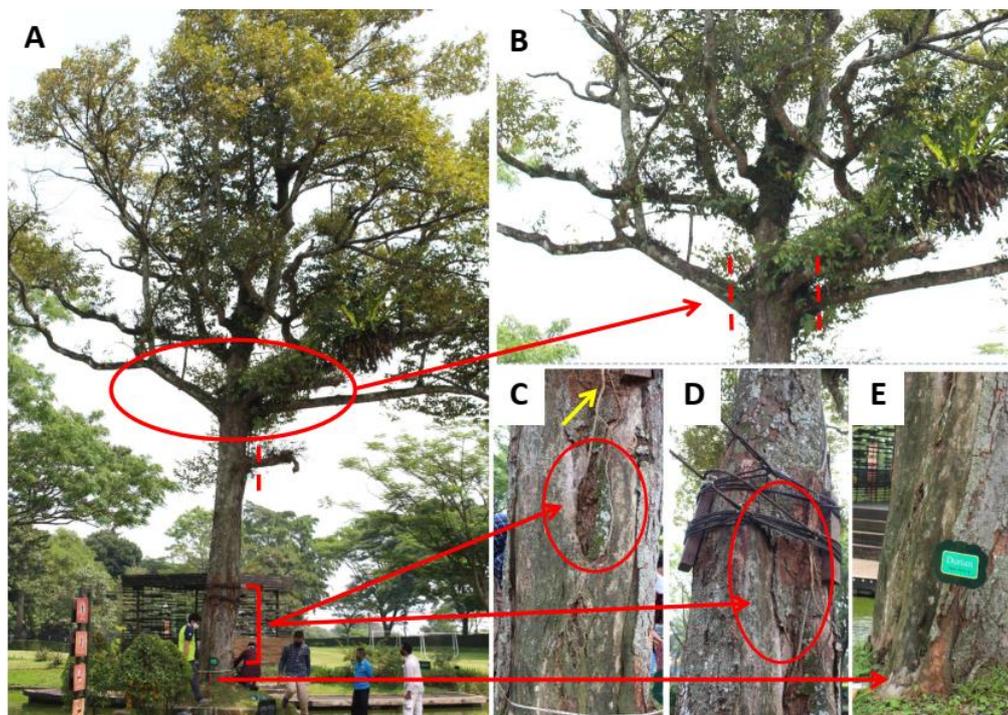
The Durian tree, located in the center of the playground area of R Hotel Rancamaya, has a crown diameter of 6 m and height of up to 12 m. The leaves on the crown are 50% tone, with any visible damage in the broken branches. Epiphytes like *Ficus* sp., parasites, and *D. crumenatum* orchids in the crown. The visual inspection results show that the primary trunk condition is still quite good even though it has been struck by lightning. The crown shows the presence of some dry and dead branches. On the tree trunk, there are *Ficus* roots (**Fig. 6c**, yellow arrows), and there is damage peeling bark so that some of the trunks are torn and dry, concave indentations (**Fig. 6c**). On the other hand, parts of the bark are also cracked and loose to not stick to the inner wood (**Fig. 6d**). In addition, at the base of the trunk and root neck, a nested path for the termite *Macrotermes* sp. attacks dead tissue/bark.

Fig. 6. Tree 3 (*D. zibethinus*). A. In whole natural appearance; B. Branches recommended for cutting (dotted red line); C. The damaged trunk with indentations are attached by *Ficus* roots (yellow arrows); D. The condition of the enduring trunk stretching of the bark; E. The root neck area shows the location of the termite trench.

The PiCUS-3 Sonic Tomograph in tree 3 was carried out on four layers at the height of 20 cm (L1), 70 cm (L2), 140 cm (L3), and 210 cm (L4). Conditions at the height of 20 cm (L1) indicate a wood solidity of 93%. Meanwhile, the subsequent layers are relatively not weathered with a very high resilience of wood, reaching >95%. Although the condition of the durian tree does not show any alarming characteristics, based on the previous history where the tree has been struck by lightning, it is necessary to do some handling to ensure that the durian trunk can support the crown's load. Several handling advice can be done. Suppose the durian tree is preserved, the recommended mitigation efforts are as follows: (1) reduction of the lowest branch because it is feared to increase the load on the trunk because the trunk is also used as a flying fox terminal, (2) transferring the flying fox sling rope to another support panel, the burden of the sling rope is feared to aggravate the trunk load, (3) provision of termiticide so that the termite queen can be attacked directly and the termite colony can be wholly eradicated, (4) installing warning signs to warn about broken branches potential hazard. If the durian tree is cut down, cut off the trunk because it is worried that it will not support the load of the crown and sling ropes.

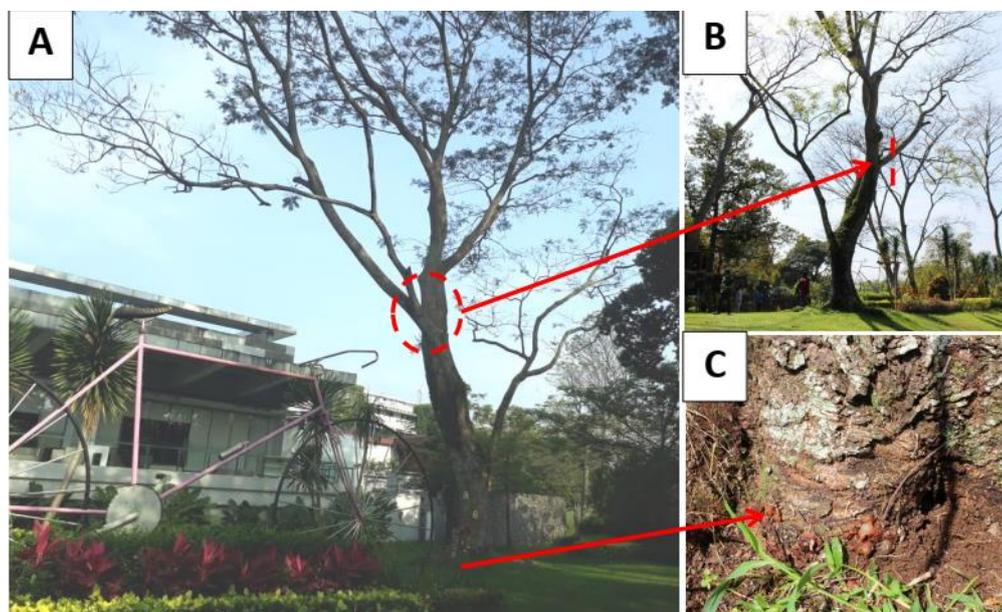
Sengon tree, which is located on the edge of the playground area of R Hotel Rancamaya, has a height of up to 11 m with a crown diameter of 9 m. The leaves on the crown look withered. On the main branch, there are epiphytic *P. piloselloides*, mosses, lichens, and *D. crumenatum*. The visual observation results showed that the condition of the trunk was quite strong, although the crown showed some dry branches and withered leaves. On the trunk of the main branching tree, there are many *P. piloselloides* spikes. On the side of the root neck, it was found that it was pretty

damp and fungal infection started to appear caused by the covering of the root neck by the thick grass (Fig. 7c).

Fig. 7. Tree 4 (*F. falcata*). A. In whole natural appearance; B. Branches recommended for cutting (dotted red line); C. The base of the trunk/root neck was previously covered by lush grass and looks like there is a fungus.

The PiCUS-3 Sonic Tomograph in tree 4 was carried out on three layers at the height of 78 cm (L1), 130 cm (L2), and 200 cm (L3). Conditions at the height of 20 cm (L1) indicated 98% wood solidity. Meanwhile, the subsequent layers are relatively not weathered with very high stability of wood, reaching 95%. Although the condition of the sengon tree does not show any worrying characteristics, some measures need to be taken to ensure that the sengon branches are not dangerous, considering that sengon wood is a wood with a low durable class in categories IV-V (Wardyani et al. 2017). The recommended mitigation efforts are as follows: (1) trimming branches that lead to the building are feared to break and endanger visitors or staff walking in the area, (2) removing the *P. piloselloides* because the epiphytes can weather the bark, (3) clean the root neck area regularly, particularly the root neck covered with lush grass that moistens and trigger fungal growth, and (4) installing warning signs.

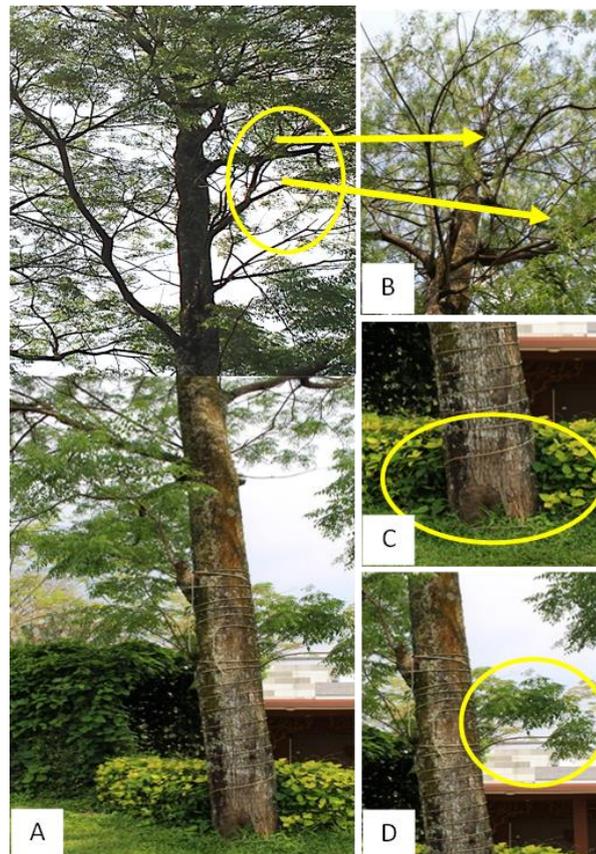
The visual observation results showed that the crown shapes of tree 5 (*M. azedarach*) were growing well, and the canopies were balanced with an estimated 5 m of diameters. The crown density is relatively average even though there are branches/dead branches of about 5-10% (**Fig. 8ab**). The growth of the trunk was reasonably good, with a trunk diameter of 2.05 m in the first layer of observation. The character of the mindi bark is known to have cracked on the outside of the trunk. Ornamental plants mainly cover the base of the trunk, so it can become damp and be attacked by fungi or termites (**Fig. 8c**).

Fig. 8. Tree 5 (*M. azedarach*). A. In whole natural appearance; B. Dead branches; C. The base of the trunk is covered with bushes; D. Branches leading to buildings will be cut off.

The PiCUS-3 Sonic Tomograph in tree 5 was carried out on three layers at the height of 50 cm (L1), 120 cm (L2), and 200 cm (L3). The condition of the trunk in the three layers observed was known to be relatively good, with a solid wood density of 96%, 93%, and 98%, respectively. This mindi tree is located in the parking area and is often a place for children to play and is visited by families of visitors. Therefore, visual inspection of the base of the trunk and dead branches is expected to regularly be carried out by the relevant department at R hotel. The recommended mitigation efforts are as follows: (1) crown reduction should be conducted by reducing the components that lead to the building but by still paying attention to the balance of the tree crown, (2) cutting dead branches is done by cutting the base of the dead branch, (3) maintenance around the root neck to get direct sunlight to prevent damp, inviting fungus and termites, (4) checking the base of the trunk and dead branches is recommended to be carried out periodically by the relevant department at R Hotel Rancamaya, and (5) installing warning signs.

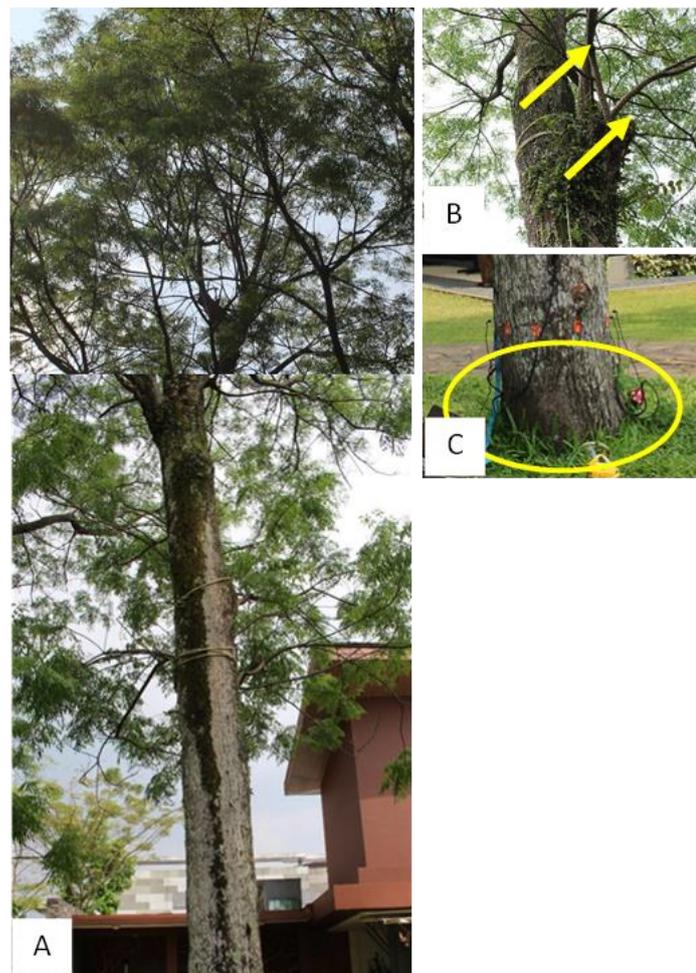
The visual observation results showed that the crown condition of tree 6 (*M. azedarach*) tree was observed to grow relatively well. The crown was quite balanced, with an estimated crown diameter of 5 m. The crown density is relatively standard, although there are branches/dead branches of about <5%. The growth of trunks is rather good, with a trunk diameter of 1.74 m in the first layer of observation (**Fig. 9a; 9b**). On the trunk, it can be seen that it is overgrown with epiphytes such as nails and orchids. Similar to other mindi trees, the bark is known to have cracks on the outside of the trunk. The trunk base is mainly covered by grass, which can become damp and easily attacked by fungi or termites (**Fig. 9c**).

Fig. 9. Tree 6 (*M. azedarach*). A. In whole natural appearance; B. Dead branches and epiphytes plants; C. The base of the trunk is covered with grasses.

The PiCUS-3 Sonic Tomograph in tree 6 was carried out on three layers at the height of 25 cm (L1), 114 cm (L2), and 200 cm (L3). The condition of the trunk in the three layers observed was known to be relatively good, with a solid wood density of 93%, 92%, and 94%, respectively. This mindi tree is located in the parking area and is often a place for children to play and is visited by families of visitors. Therefore, visual inspection of the base of the trunk and dead branches is expected to regularly be carried out by the relevant department at R hotel. The recommended mitigation efforts are as follows: (1) crown reduction is made by reducing the components that lead to the building but by still paying attention to the balance of the tree crown, (2) cutting dead branches is done by cutting the base of the dead branch, (3) efficiency reduction, carried out by removing the efficiency plants periodically, (4) maintenance around the root neck to get direct sunlight, prevent dampness, fungus, and termites, (5) checking the base of the trunk and dead branches are recommended to be carried out periodically by the relevant department at R Hotel Rancamaya, and (6) installing warning signs around the tree.

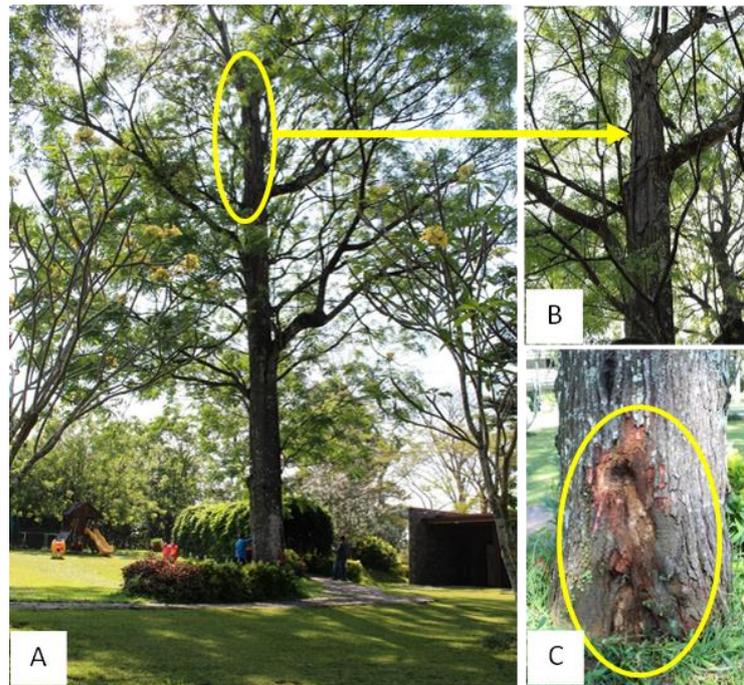
The visual observation results showed that the trunk was damaged at the tip of the trunk (**Fig. 10b**) and the trunk/root neck (**Fig. 10c**). Damage to the tip of the trunk is cracked the skin peels off. In addition, there are logging residues that have weathered due to an alleged error in felling techniques. The type of trunk wound on the tree is an advanced level of destruction caused by pests to form holes inside the tree, especially in woody trees (Costa et al. 2020). The base of the trunk/root neck termites *Macrotermes* sp., which attacks dead tissue/bark. In addition, fungi were also found in that section. It indicates that the weathering process has occurred.

Fig. 10. Tree 7 (*M. azedarach*). A. In whole natural appearance; B. Damage to the upper trunk, there are cracks and weathering processes on the rest of the previous felling; C. The base of the trunk that attacked by termites.

The PiCUS-3 Sonic Tomograph in tree 7 was carried out on four layers at the height of 5 cm (L0), 48 cm (L1), 118 cm (L2), and 200 cm (L3). The condition at the height of 5 cm (L0) is indicated to have experienced a weathering process of 18% with a wood solidity of 68%. Meanwhile, the following layers are relatively not weathered, with wood solidity reaching >90%. However, in our opinion, this condition has a higher risk of falling because the root neck has been weathered while the layers above are still solid so that the top load is heavy. Therefore, the recommended mitigation efforts are as follows: (1) complete felling because the load on the crown and trunk is solemn while the trunk/root neck base has weathered, (2) heavy felling, not cut down, but the trunk is left 1-2 m for artistic optimization with attractive decorations for hotel visitors, (3) maintenance around the root neck ensures direct sunlight, not damp, inviting fungus and termites.

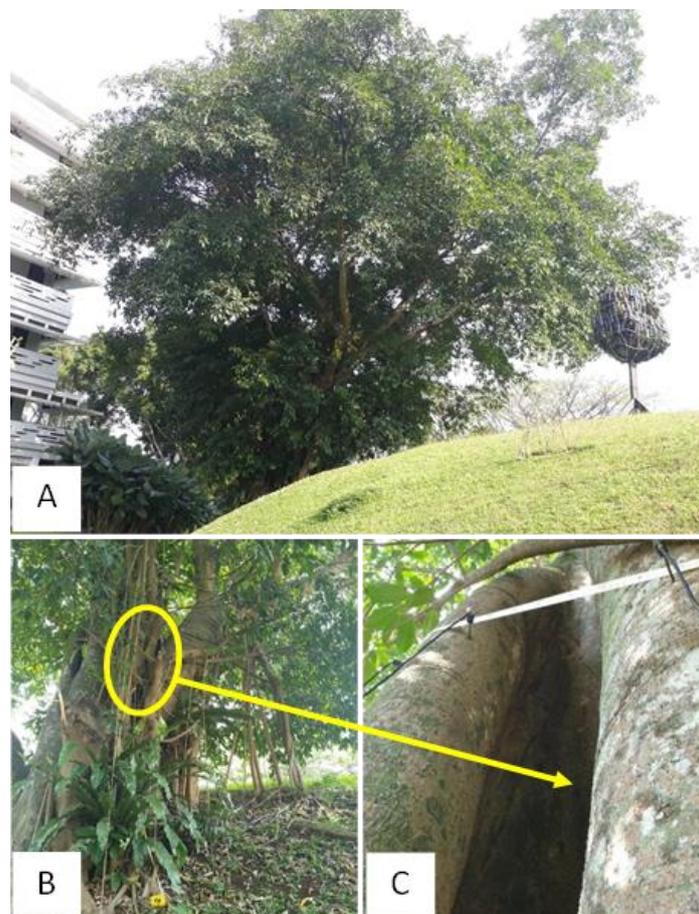
The visual observation showed that the trunk had no symptoms of damage. The cavities/indentations in the trunk are the natural shapes that are common in the development of *F. subcordata*. A hole at the trunk base happens due to a pile of soil that causes weathering. The former *Ganoderma* fungus was also found. However, the chance of falling is relatively low due to the adaptability of *Ficus* sp., which supplies growth to a form of self-defense by emerging new hanging roots (**Fig. 11**).

Fig. 11. A. The whole appearance of *F. subcordata*; B. Cavities due to the natural curve of the tree growth.; C. Cavity condition with no symptoms of damage.

The PiCUS-3 Sonic Tomograph in tree 8 was carried out on three layers at the height of 200 cm (L1), 230 cm (L2), and 280 cm (L3). In general, the trunk of *F. subcordata* is still in a safe condition. As for the check results, the blue color results from natural cavities/indentations that do not indicate weathering/damage. In addition, the position of the crown is included in a balanced condition according to the contour and direction of the crown slope. Therefore, we assessed that the condition of *F. subcordata* is in a relatively safe situation. Therefore, the recommended mitigation efforts are as follows: (1) tree felling is not necessary, (2) pruning branches to the building can perform in a limited way by considering the balance of the tree's weight, and (3) placing signage for caution to visitors.

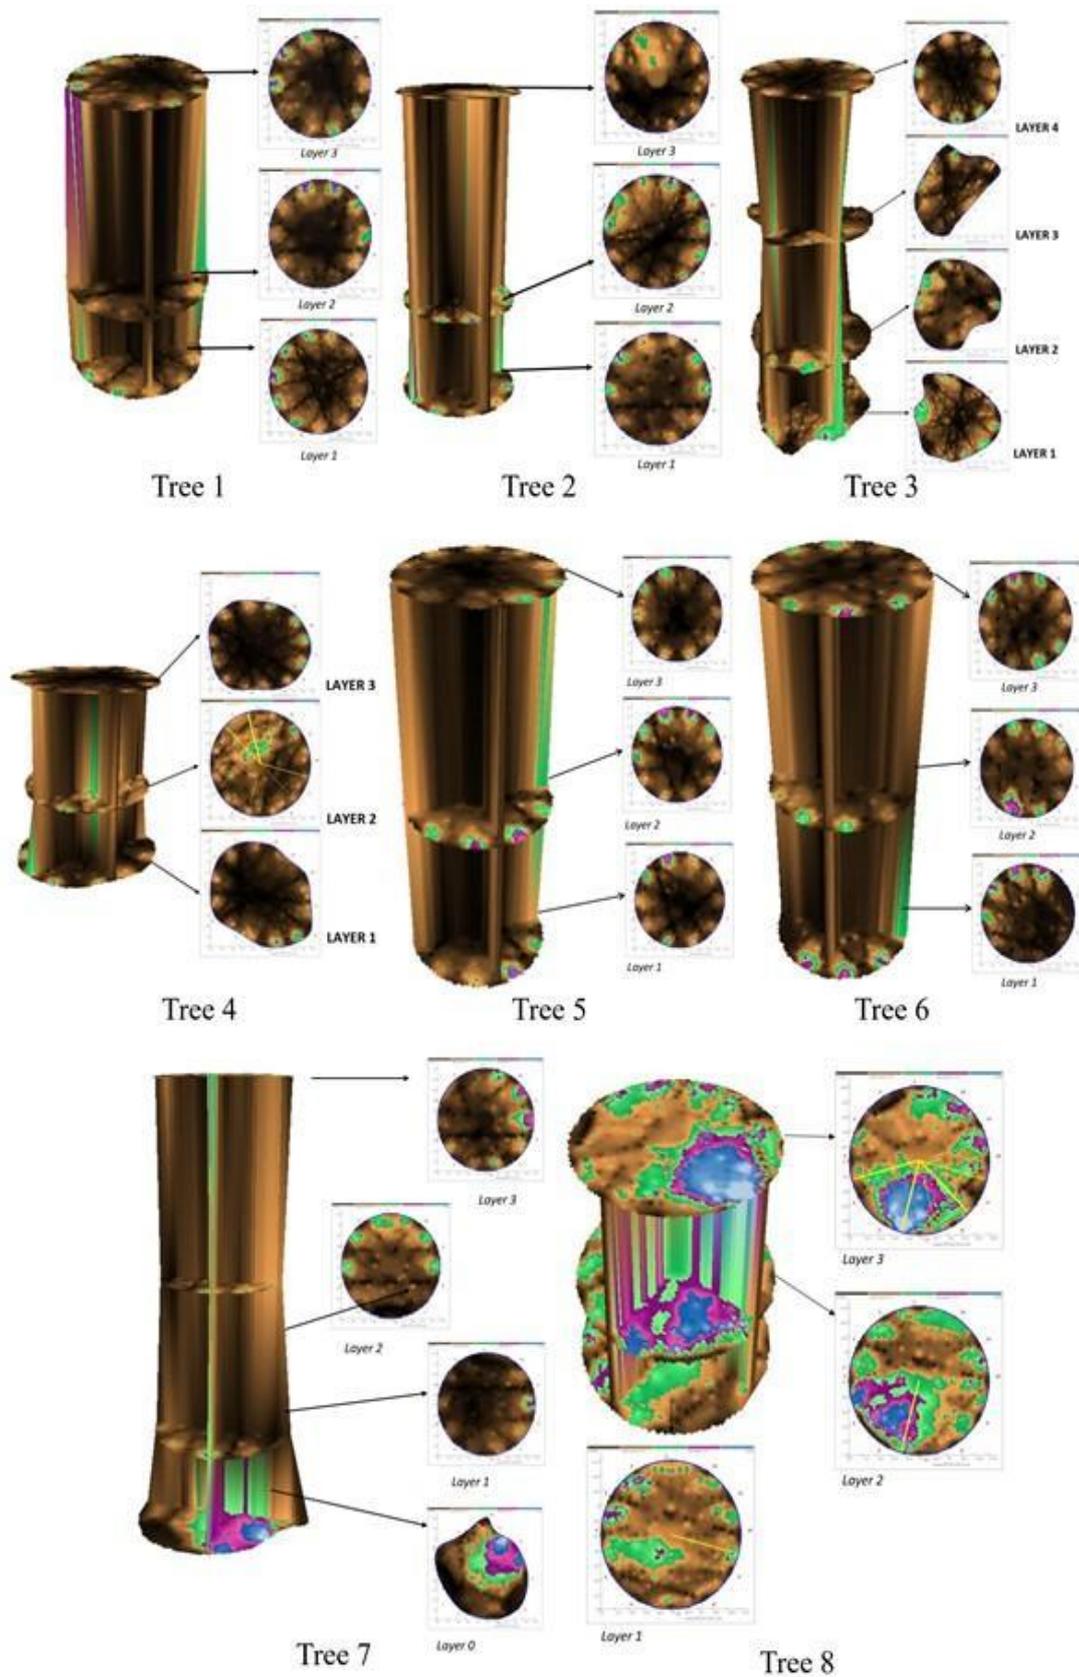
Fig. 12. The tomogram of eight risky trees.

The tomogram of eight risky trees is presented in **Fig. 12** and the detailed assessment results for each tree are described in the following sections. The PiCUS-3 Sonic Tomograph in tree 1 was carried out on three layers at the height of 30 cm (L1), 80 cm (L2), and 180 cm (L3). Good condition of the trunk at the height of 30 cm (L1), 80 cm (L2), 180 cm (L3) indicated that it had only experienced a 1% weathering process with 95% wood solidity. This condition is considered
