# Biological Deterioration of Wooden Components of *Balla Lompoa Ri Galesong* in South Sulawesi, Indonesia

Astuti Arif<sup>1,\*</sup>, Giselowati Putri<sup>1</sup>, Andang Suryana Soma<sup>1</sup>, Syahidah<sup>1</sup>, Syahribulan<sup>2</sup>

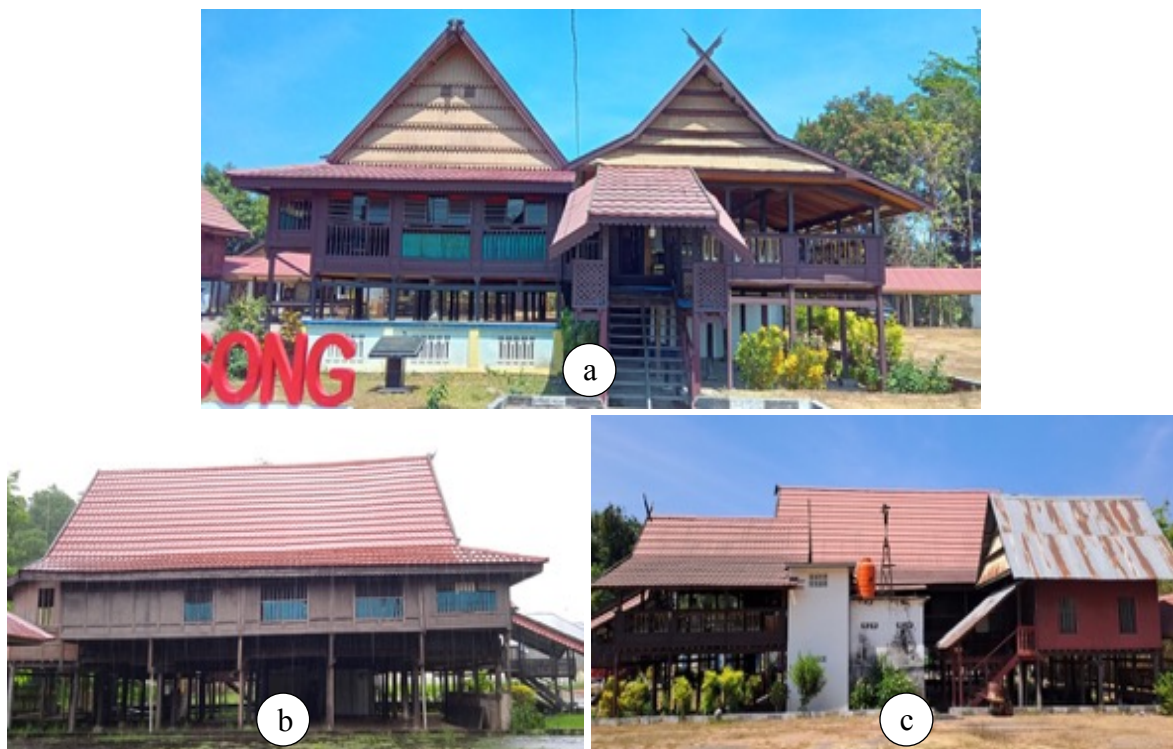
**Fig. 2.** The traditional building of *Balla Lompoa Ri Galesong*: (a) front view, (b) left side view, and (c) right side view.

The *Balla Lompoa Ri Galesong* has one main building with two forms of profiled tin roofs, initially made of palm fiber (**Fig. 2a**), and one additional building as a kitchen with a tin roof (**Fig. 2c**). Considering that this building still functions as a residence for the descendants of Karaeng Galesong, another additional building is made of bricks used as a bathroom and toilet (**Fig. 2c**). The components of this building structure are made of teak wood (*Tectona grandis* L.f.), which is known to have a high strength and durability class. Pillars are placed on rectangular stones to maintain contact with the ground as a source of moisture.

Before using brick houses, the community of South Sulawesi built wooden houses, known locally as ‘*rumah panggung*’ (**Fig. 2**). This wooden house architecture is also found in *Balla Lompoa Ri Galesong*, using wood to connect parts instead of nails, known as ‘*pasak*’. The wooden components in the building structure observed were pillars, windows, doors, stairs, walls, floors, and ceilings. The upper parts of the building (roof) were not observed and measured for personal reasons by the building owner. The damaged wooden components are presented in **Table 2**.

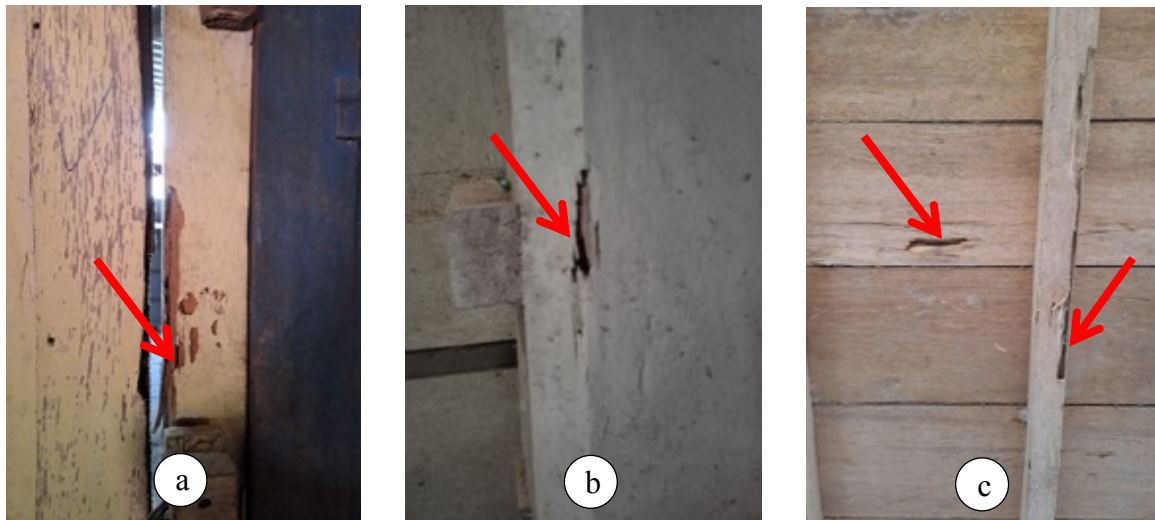
Termites are xylophagous insects that decompose the cellulose of dead wood (Mugerwa 2015) and lignocellulosic waste, such as paper products, and also known as structural pests such as wooden structures, household furniture, books, and museum collections (Govorushko 2019). This study found traces of drywood termite attacks on wooden components from *Balla Lompoa Ri Galesong*, although individual organisms could not be collected due to their absence. Drywood termites belong to the Family Kalotermitidae, which can survive without contact with the soil and only depend on their food source. Workers of these termites deteriorate the dried structural sawn timber and wooden furniture. In this study, the part of the building attacked by these termites was the frame doors, pillar connecting beams, floors, and support beams. Damage caused by drywood termite attacks was indicated by internal damage, rough brown grains in the galleries, and a layer of wood as thick as veneer covering the galleries. Symptoms of damage are shown in **Fig. 3**.

No termite specimens were found in the gallery during the study; wood deterioration was caused by *Cryptotermes* based on the visible traces and characteristics of the damage. The appearance of the wood becoming porous, the presence of a thin layer of wood remaining on the surface of the wood, and the presence of small brownish excrement grains which often fall on the floor or around the attacked wood are symptoms of attack by *Cryptotermes cynocephalus* (Arif et al. 2019).

Fig. 3. Damage and open galleries caused by drywood termite attacks on (a) door frames, (b) pillar connecting beams, and (c) floors and floor supporting beams.

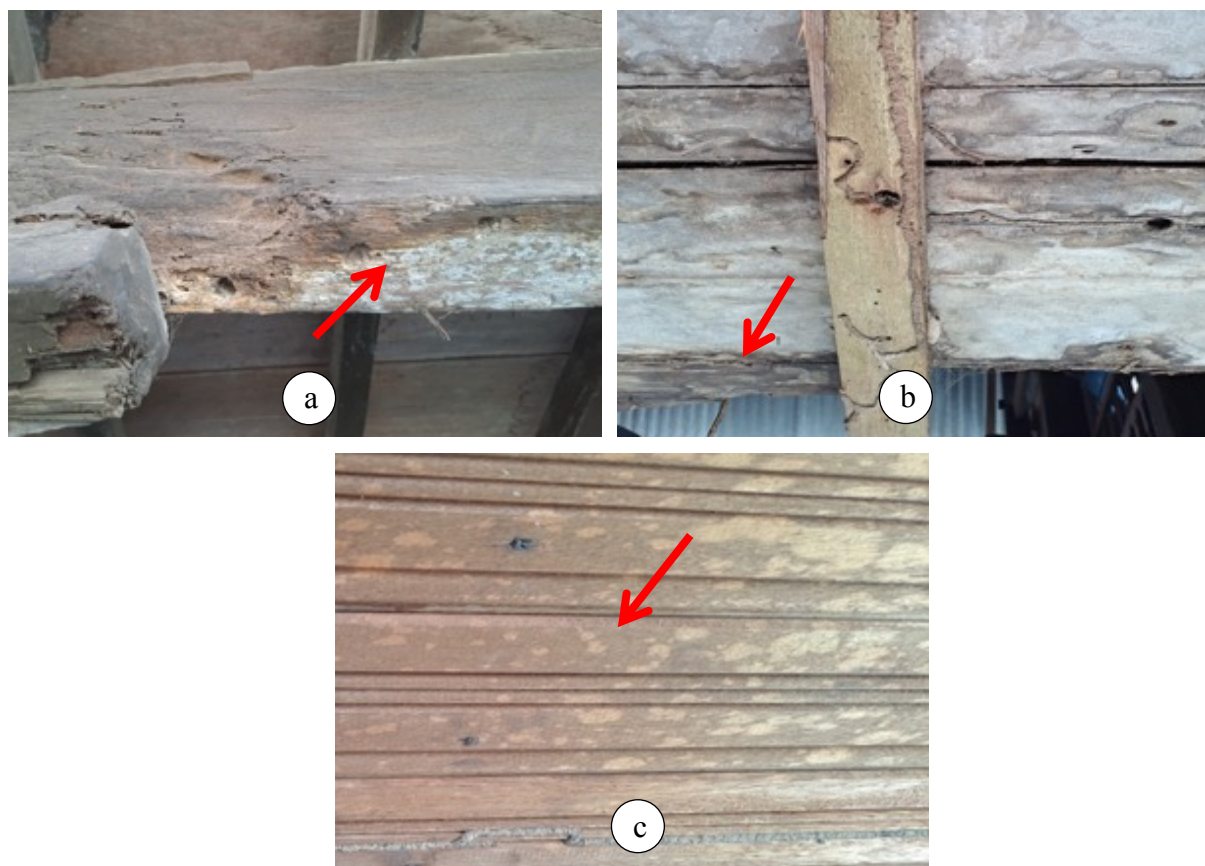
Wood-decaying fungi are biodeterioration agents that decompose wood cell wall polymers by involving enzymatic mechanisms, using either hydrolase or oxidase enzymes (Ezeilo et al. 2017). These fungi can be classified into white-rot fungi, brown-rot fungi, and soft-rot fungi based on the type of decay, with the ability to degrade partially or entirely the primary chemical components of cell walls (Procópio and Barreto 2021; Schmidt 2006). White-rot fungi can decompose lignin, cellulose, and hemicellulose, and brown-rot fungi can degrade holocellulose but can not degrade lignin and modify its chemical properties (Li et al. 2022). In the *Balla Lompoa Ri Galesong* building, the activities of these microorganisms can be seen on the beams connecting the pillars, the bottom surface of the floor, and the ceiling (Fig. 8).

**Fig. 8.** Biodeterioration symptoms are caused by wood-decaying fungus on (a) the beam connecting the pillars, (b) the bottom surface of the floor, and (c) the ceiling.
